Conservation Area

HEADLEY

Introduction & Brief History

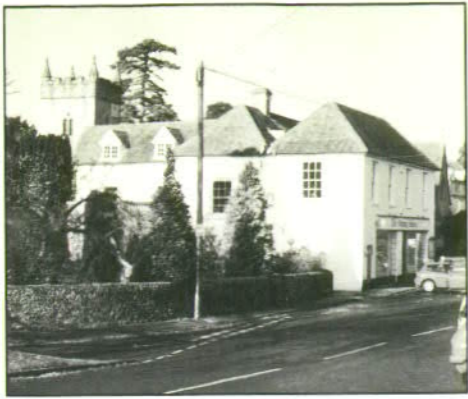
When viewed from the Hollybush looking north west, Suters, the Post Office and the church form an important group creating an interesting vista of tiled gables and hipped clay peg tile roofs. In the background is the square church tower. All of these features are 'framed' amongst trees.

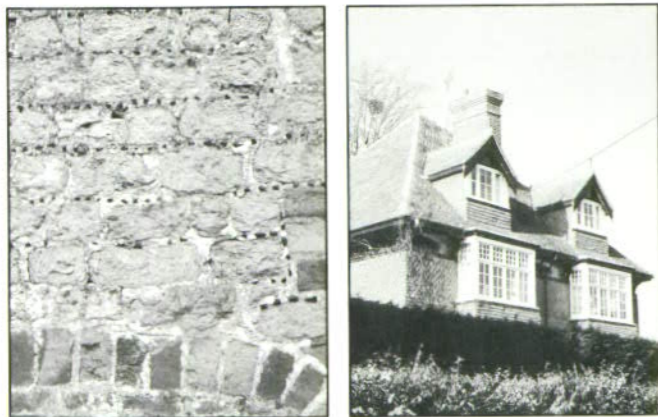
A feature of the Conservation Area is the use of local sand stone and ironstone (locally known as 'firestone') for boundary walls and several houses. *The stone is laid as randomly coursed cobbles; the joints are often galletted with small chips of ironstone.*

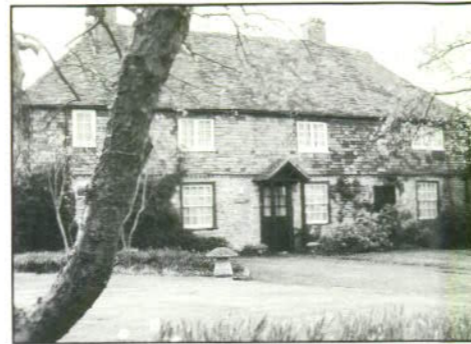
Suters is an historically important building in the Conservation Area. From the outside Suters appears to be an 18th Century house; its first floor is tile hung and ground floor built of sandstone rubble.

However, this building is in fact a Wealden House and one of very few in Hampshire. It dates from the 15th Century and was an important house in the village. The original timber frame and jettied projecting bays can be clearly seen in the gable end wall facing the churchyard. The interior has medieval wall paintings. A sixteenth century chimney has been added to the original open hall.

On the west side of the High Street but near to the Mill Lane junction lies Suters, a Hampshire Wealden house. It is set back from the road and marks the entrance to the High Street.

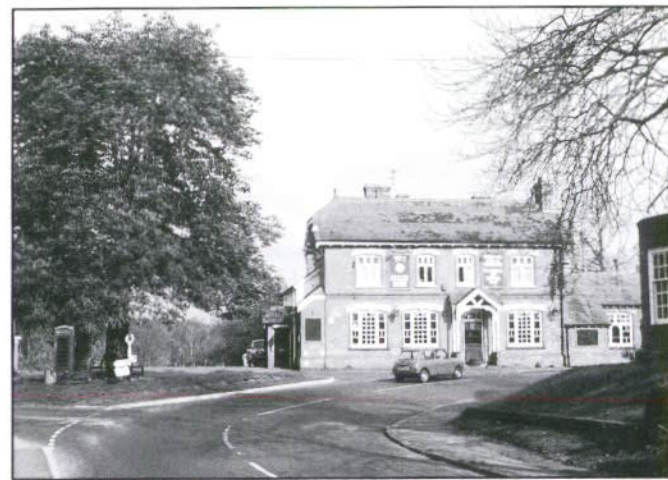
The tree and the Hollybush Public House (an Edwardian house of 2 storeys of orangefred brick) form a visual stop to views from Mill Lane. Together with the more modern Bank (circa 1930's) on the south side of Mill Lane they both shape and enclose the

A large chestnut tree is the focus of the small triangular Green formed by the intersection of the High Street and Mill Lane. The tree is surrounded by an iron seat. A cast iron finger post is also a small but important feature of this Green. The Stocks were once located on the green.
